The Chesapeake Bay Breakwater Database Project Hurricane Isabel Impacts to Four Breakwater Systems

Shoreline Studies Program
Virginia Institute of Marine Science
College of William & Mary

May 2005

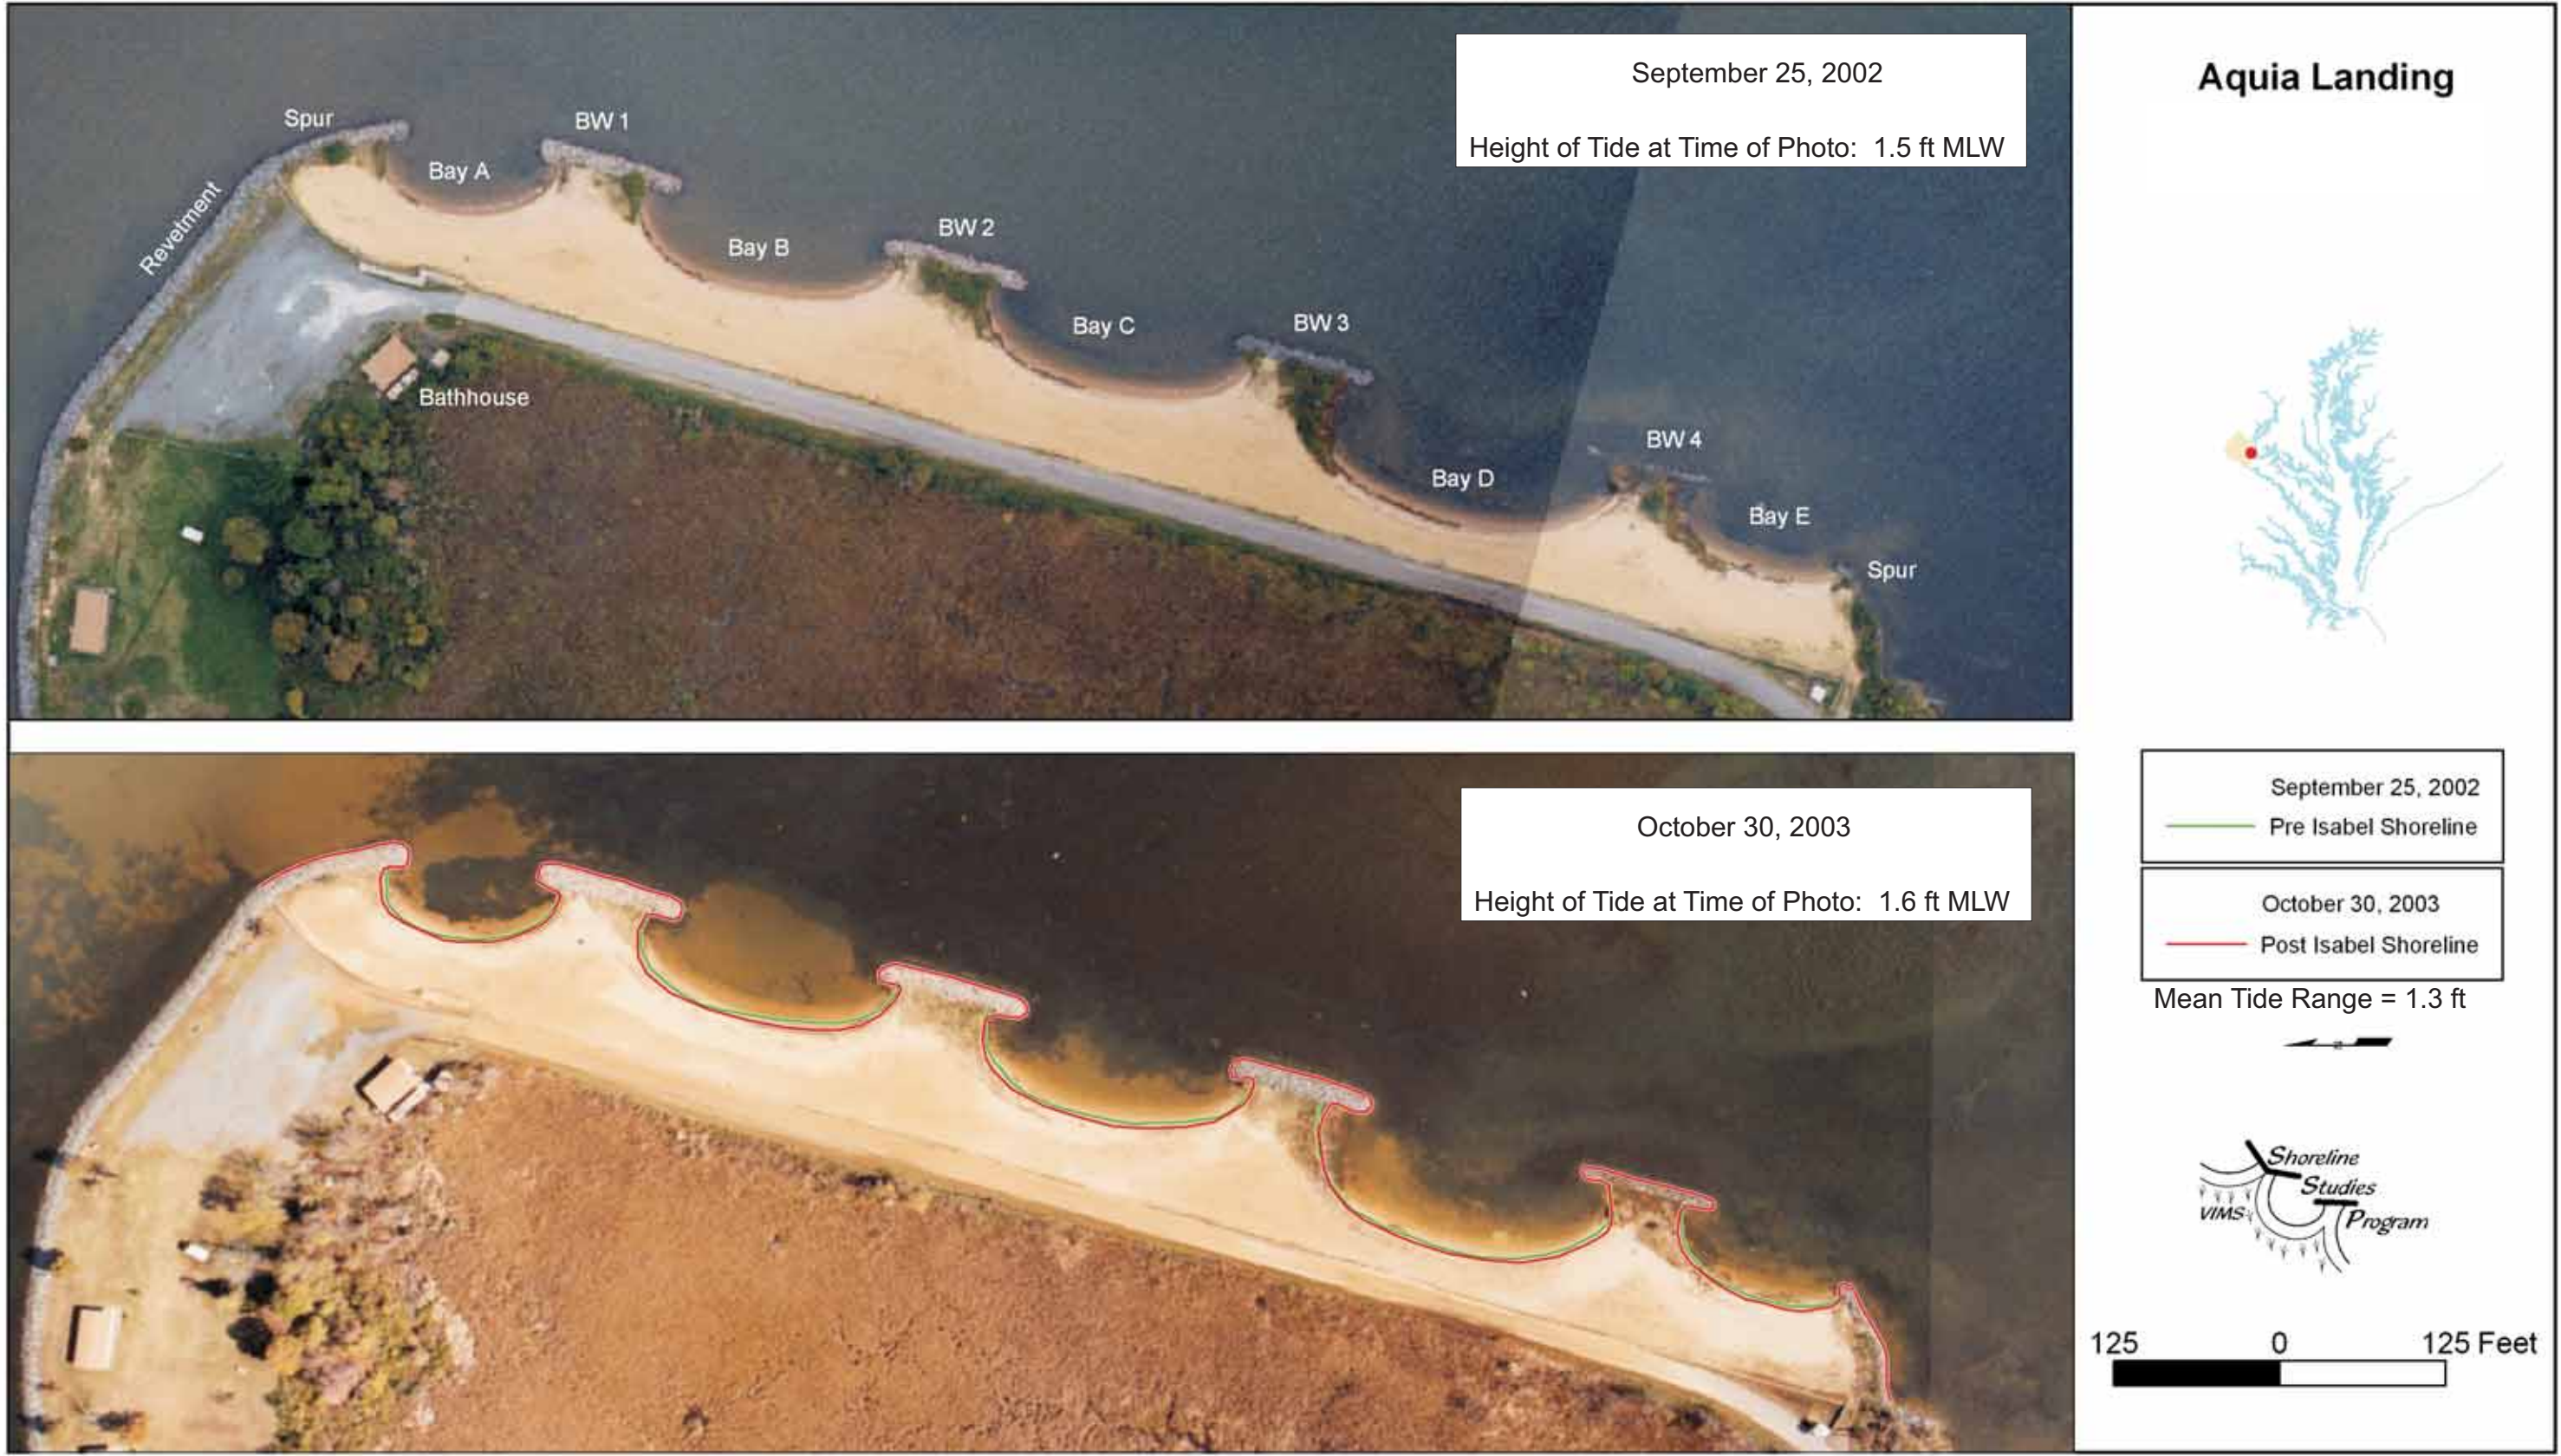
Aquia Landing was the least impacted by Hurricane Isabel of the four sites discussed in this report. It had the least storm surge and it was not directly impacted by wave attack. Nevertheless, the storm impacts were enough to carry sand into the access road due to the low backshore and the absence of an upland bank. However, no significant infrastructure was damaged at the site. Overall, this site fared very well with little or no impact.

Figure 15. Aquia Landing low-level pre- and post-Hurricane Isabel ortho-rectified aerial photos.

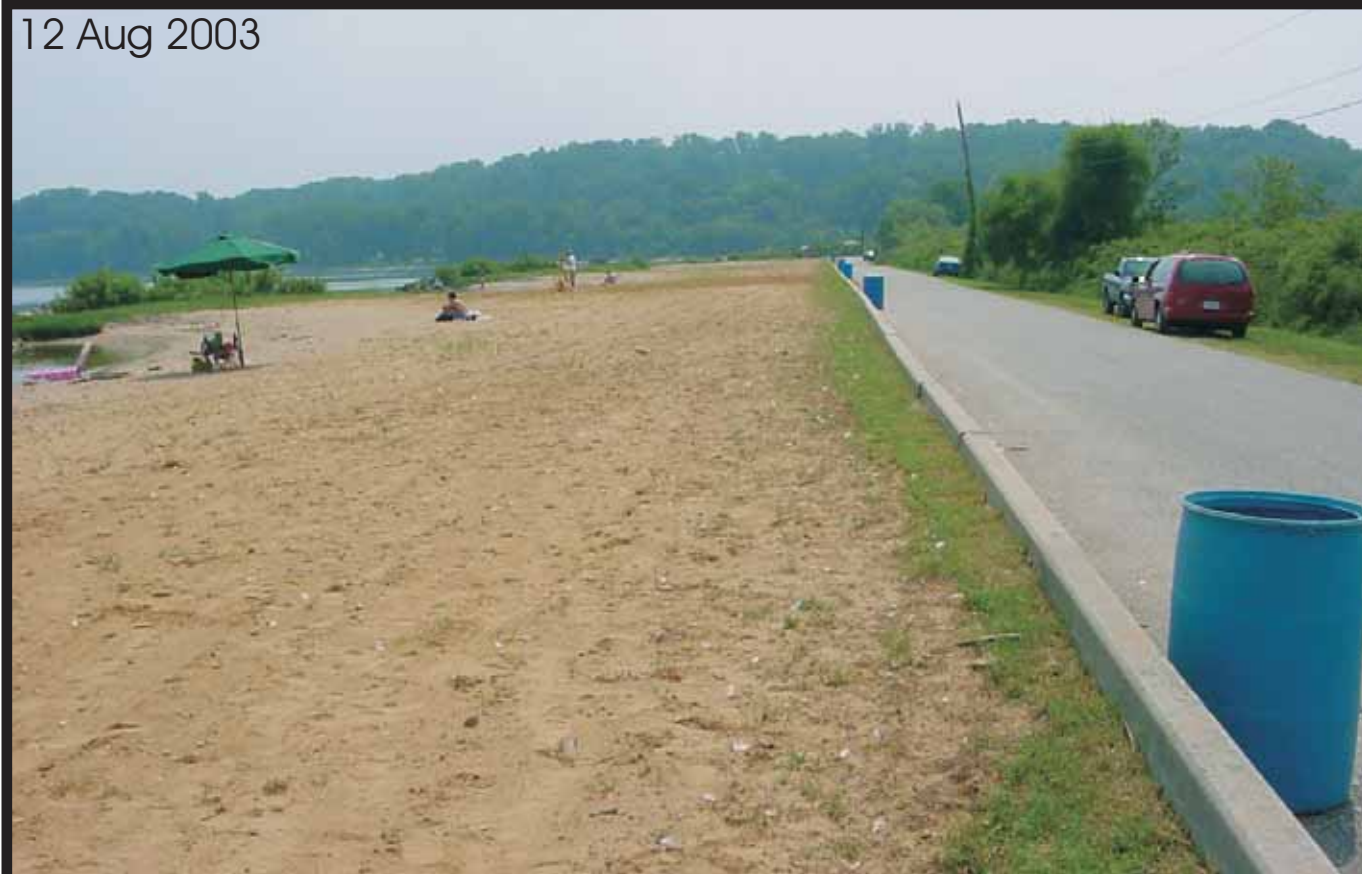
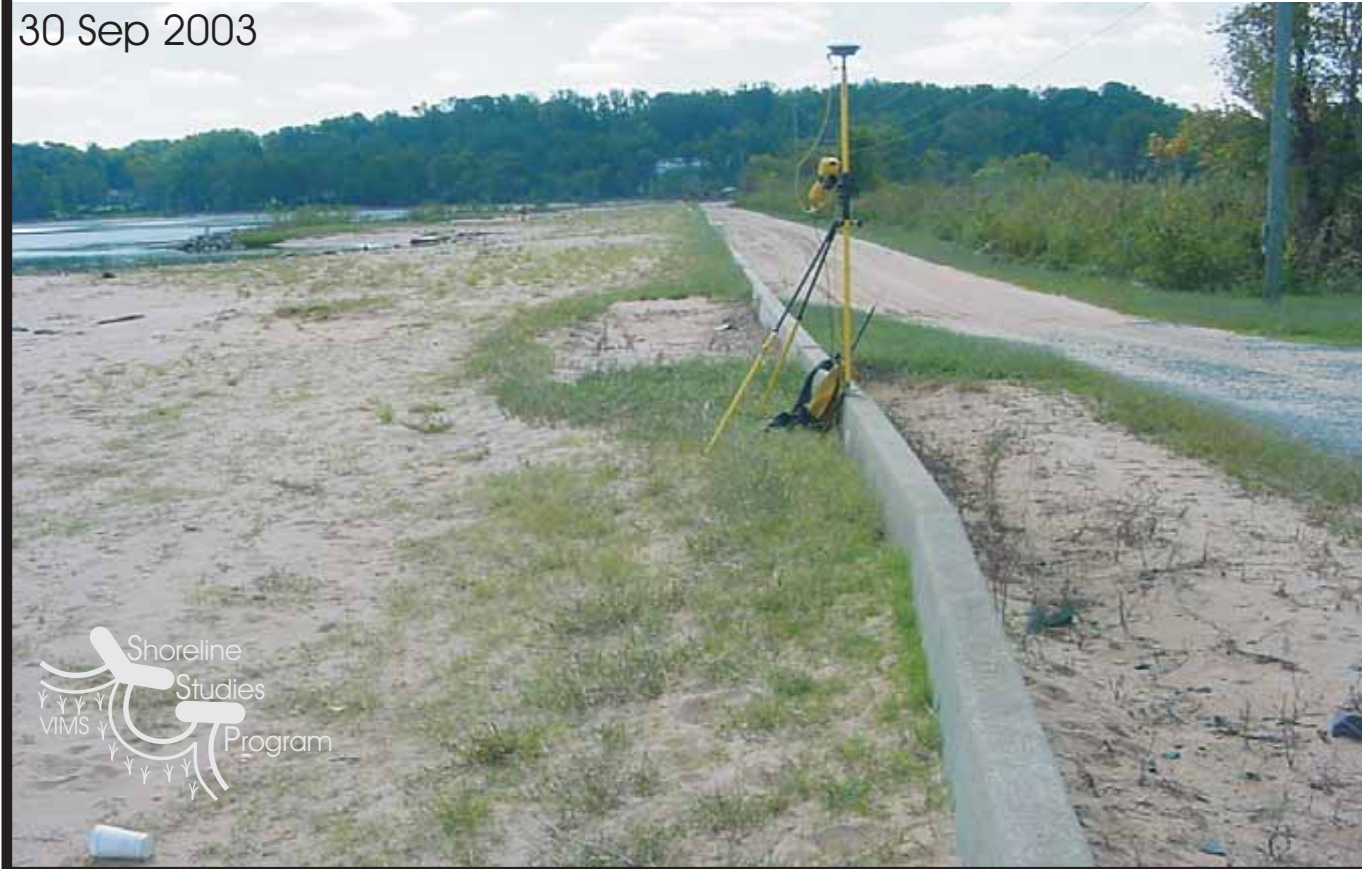
Looking south along the Jersey wall and access road

Figure 17. Aquia Landing ground photos before and after Hurricane Isabel.

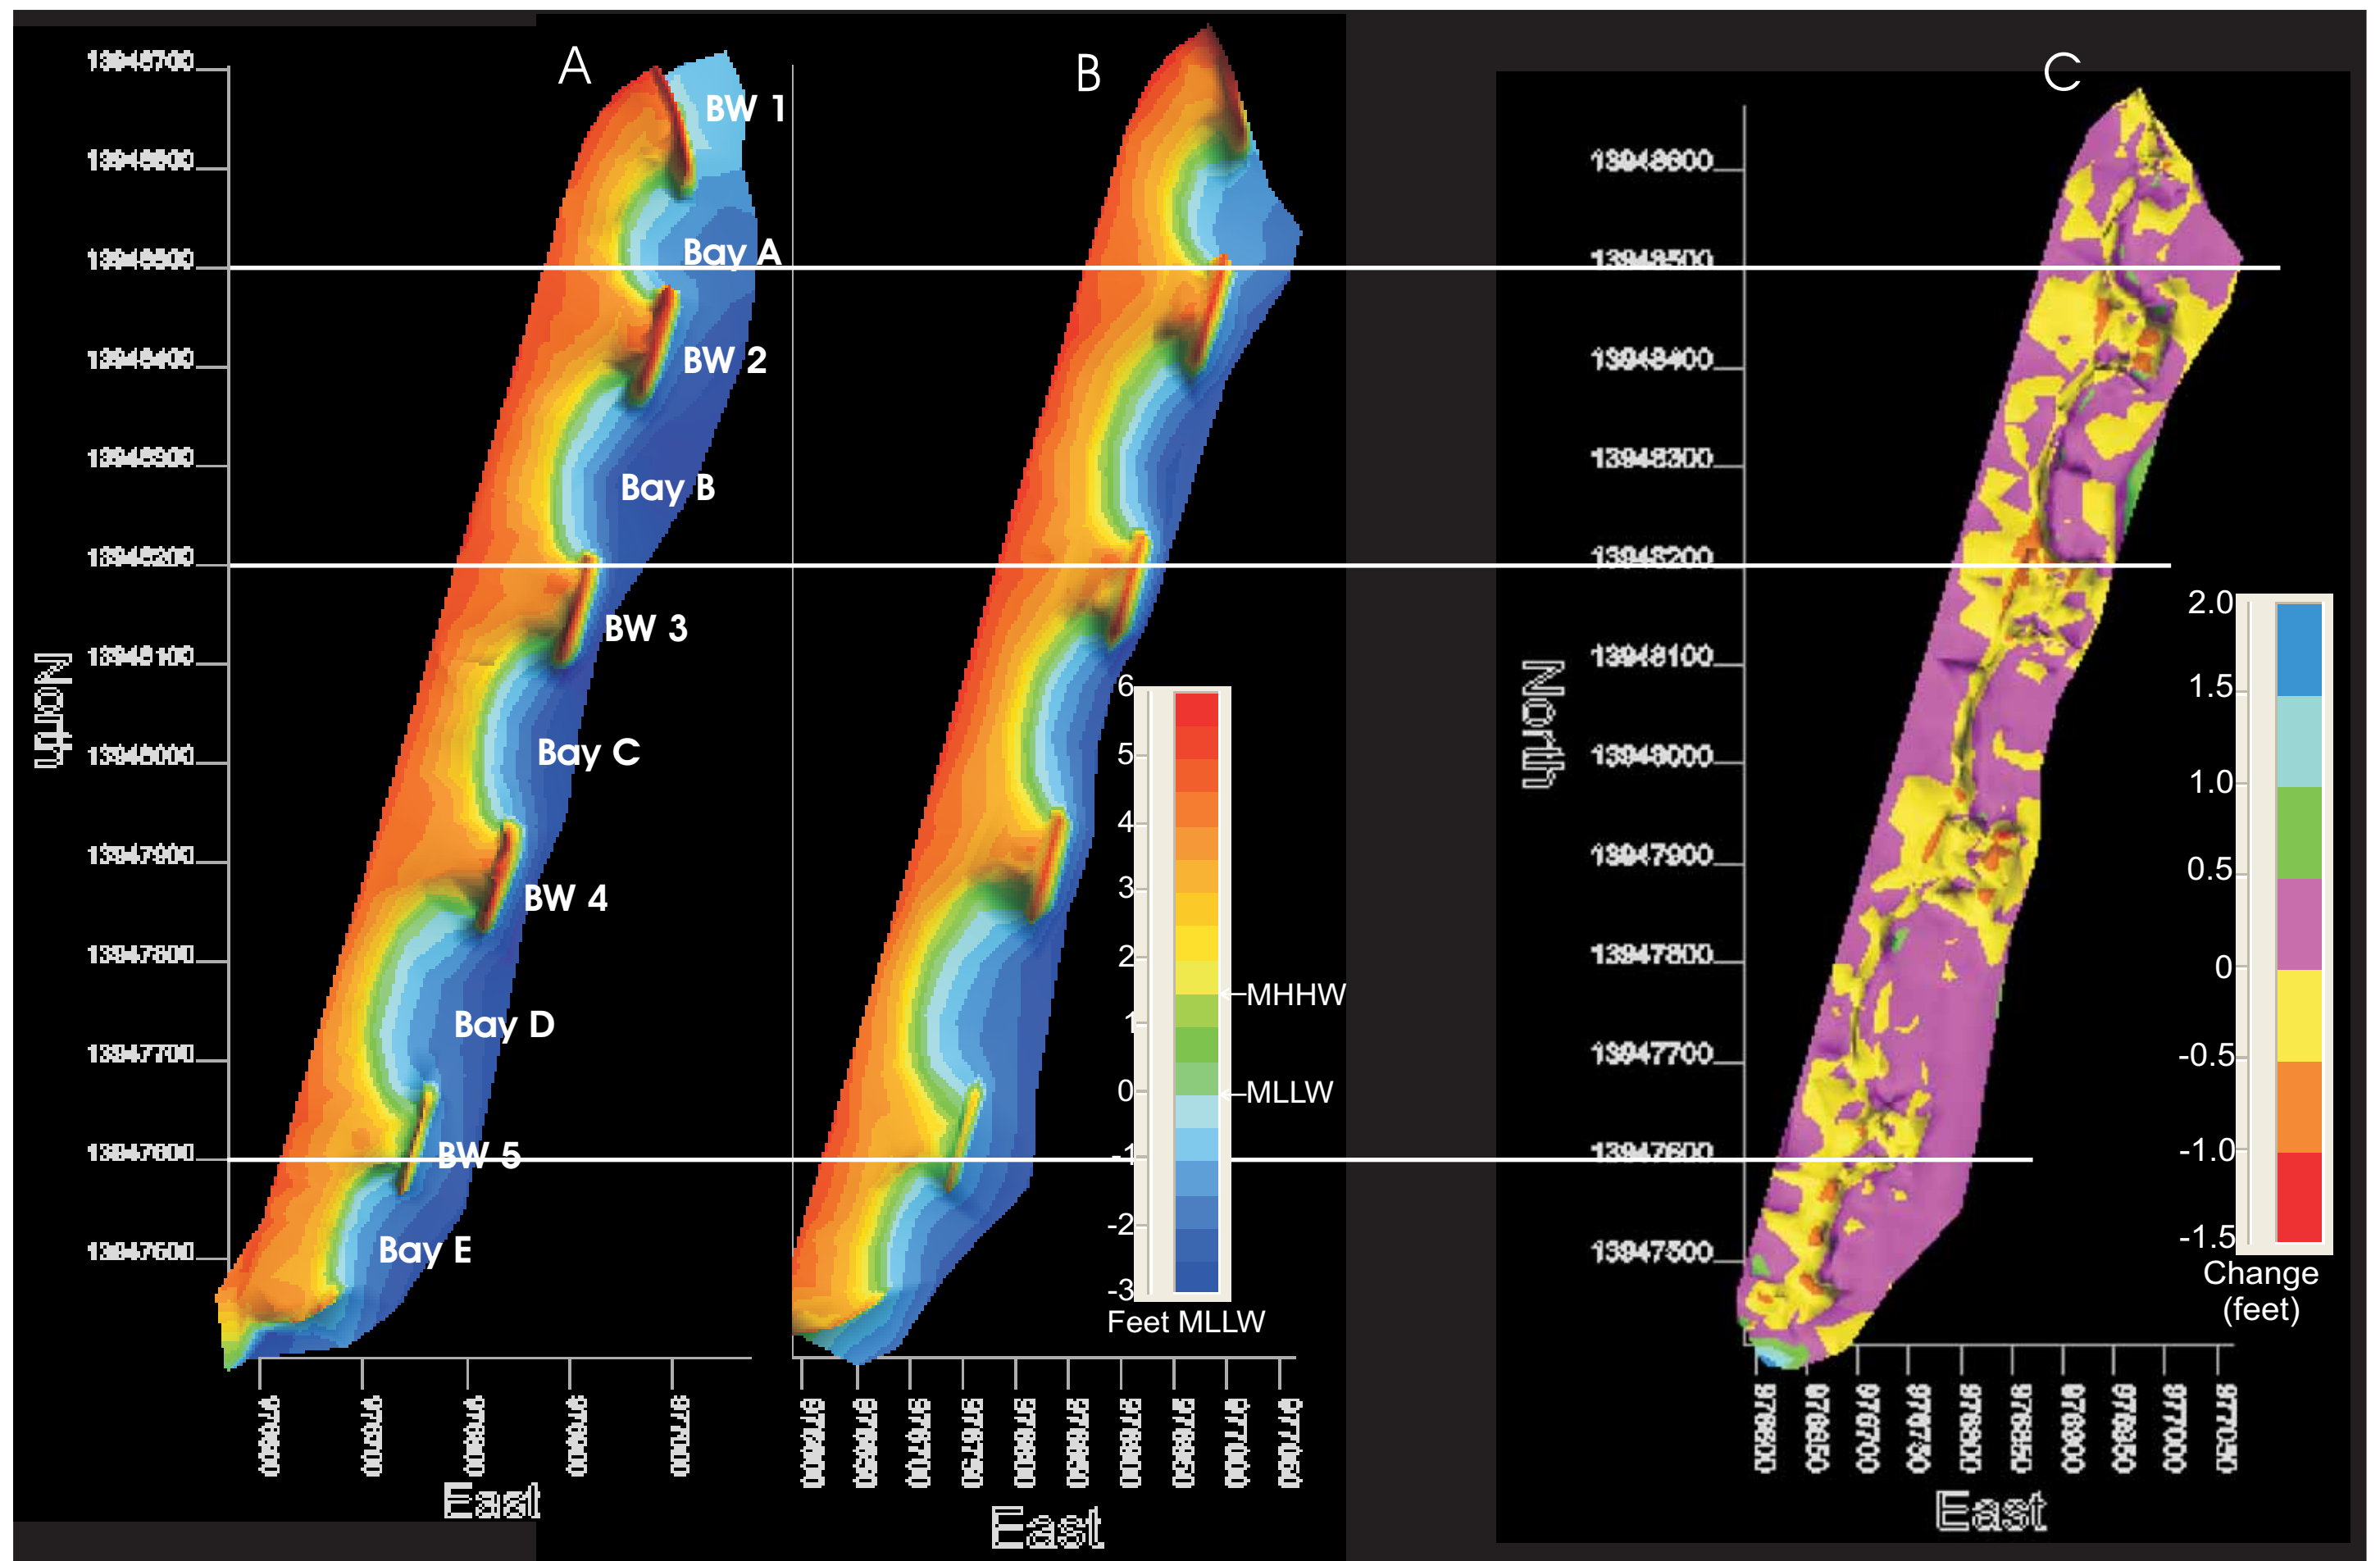
Figure 18. Aquia Landing color contour maps for the A) pre- and B) post-storm conditions, and C) isopach map showing elevation changes between surveys.

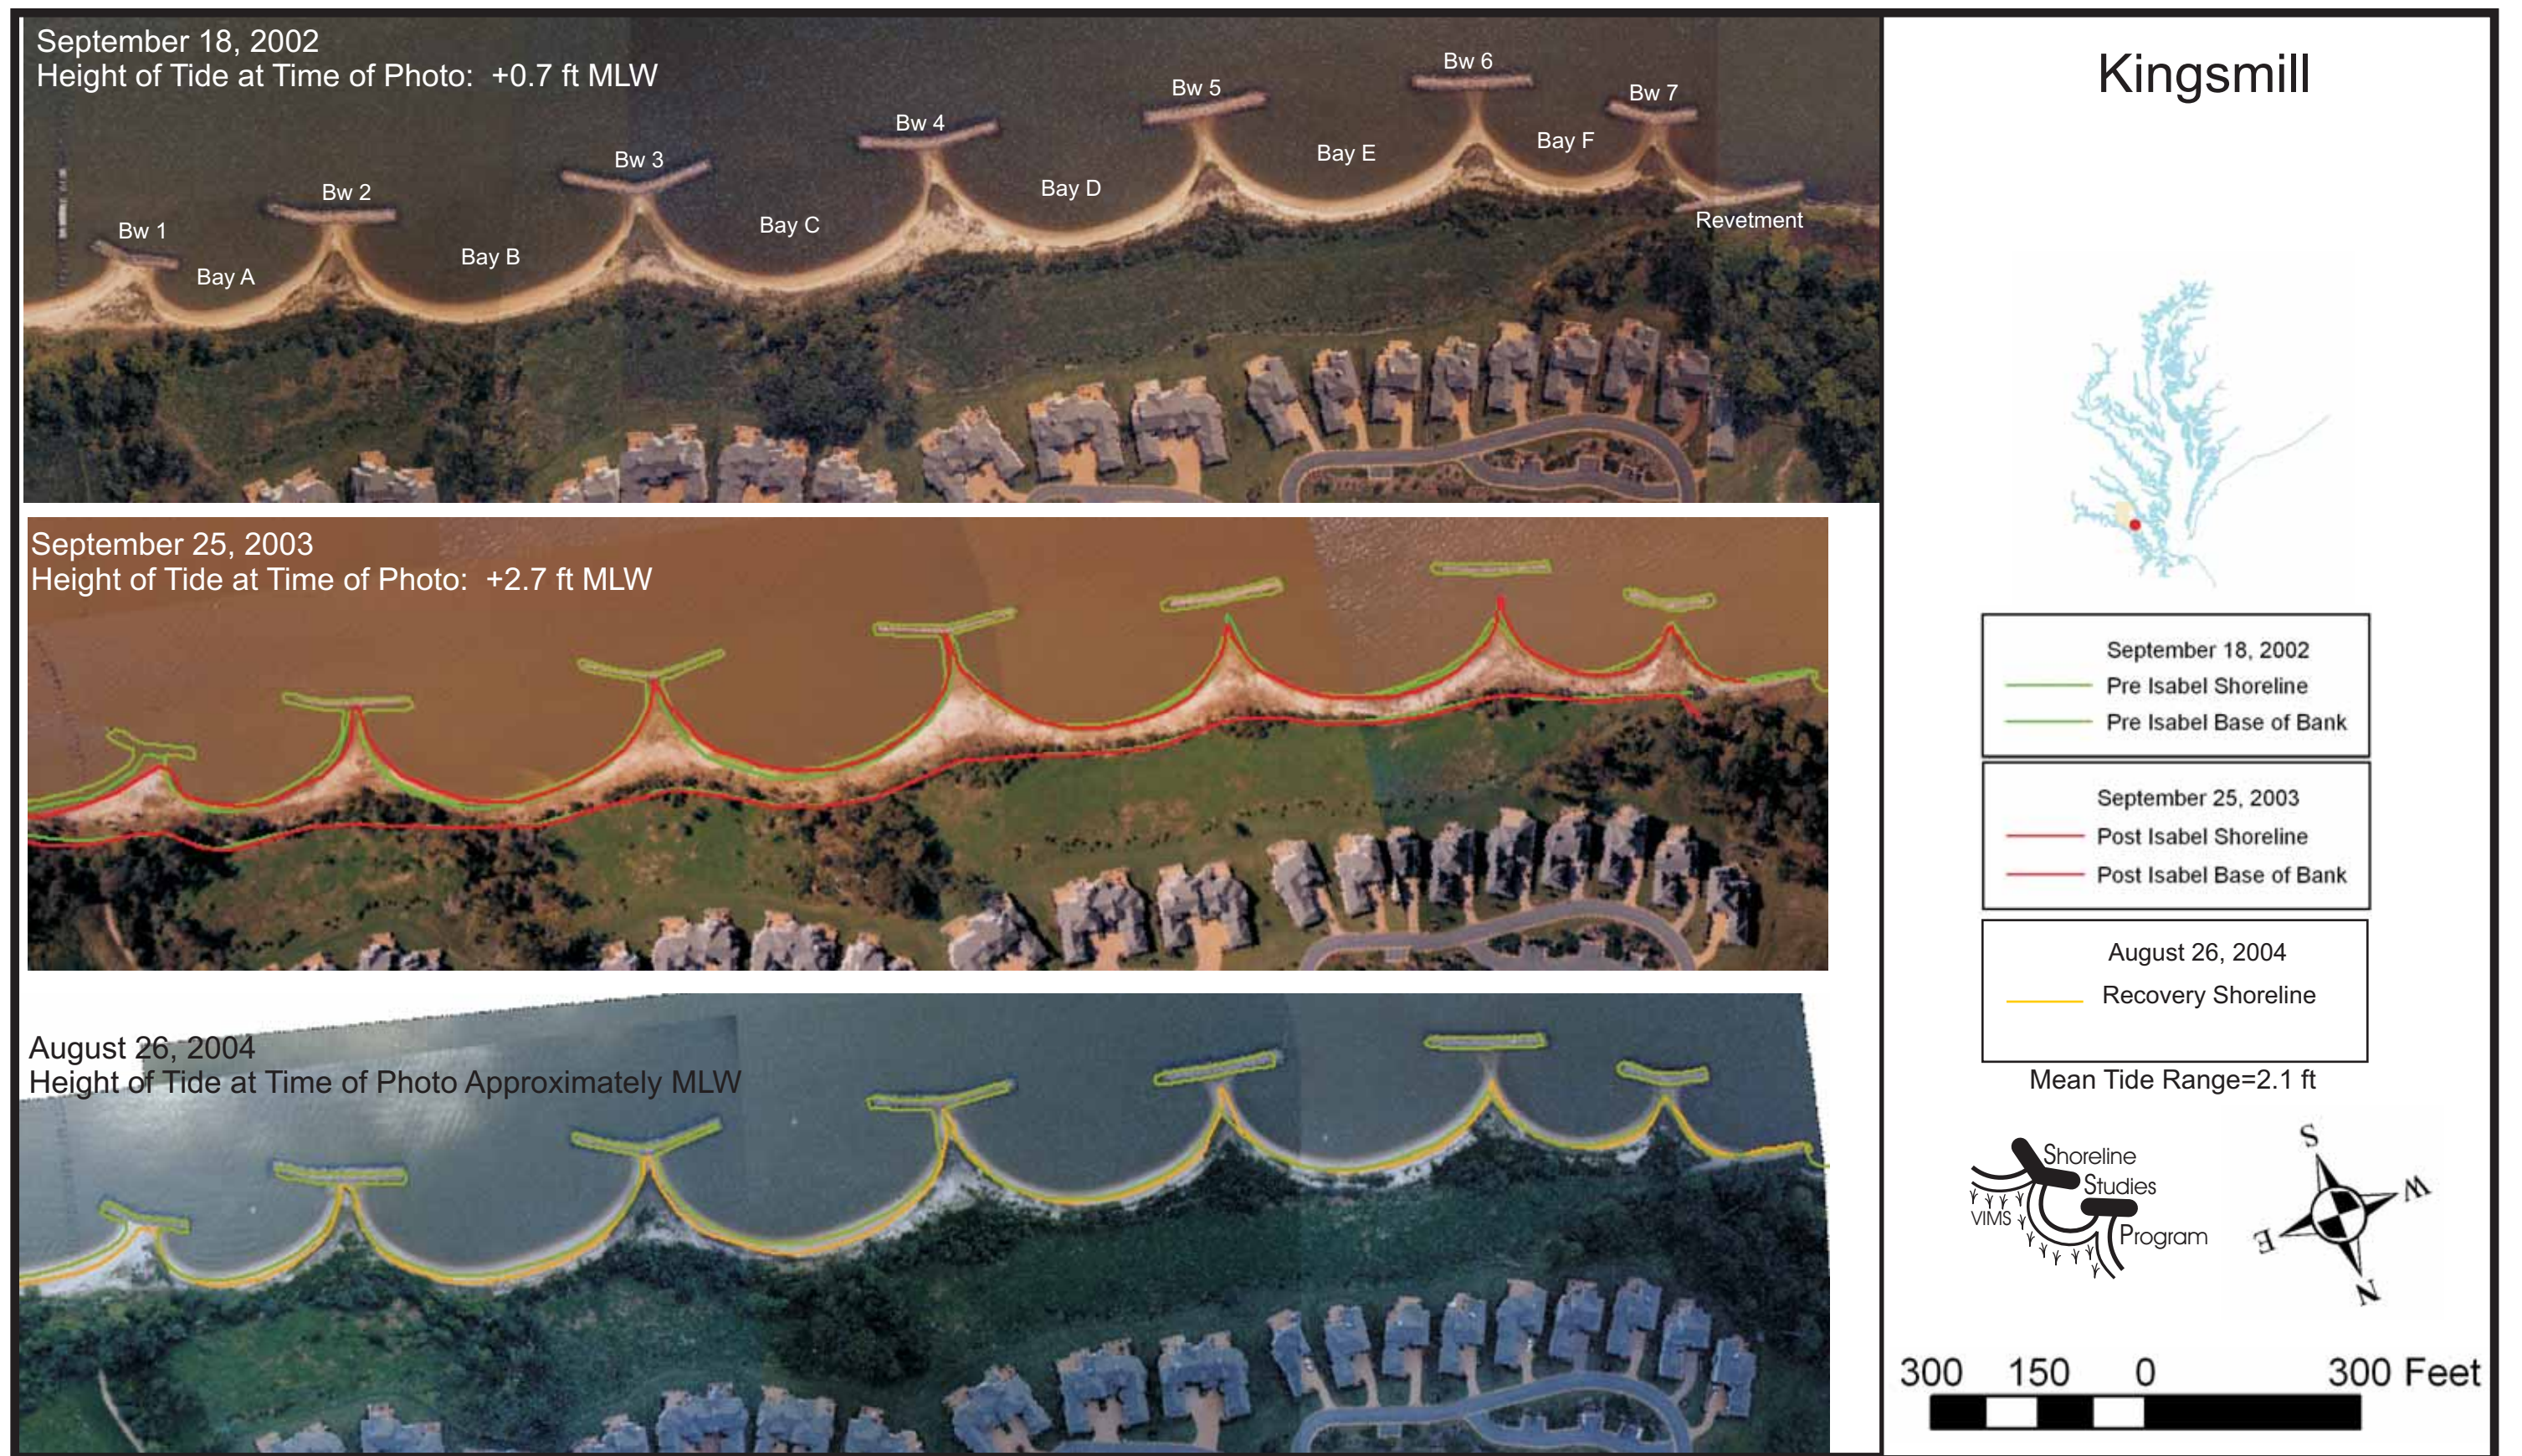
Pre- and post-Isabel aerial imagery of the site show slight changes in shore position (Figure 19). Each tombolo apex had a tendency to shift upriver. Measurable base of bank recession occurred along much of the project, but it was particularly prevalent adjacent to each embayment. These changes are illustrated in the typical bay and breakwater profiles in Figure 20. The combination of storm surge and wave runup limits were measured in the field and are shown for each typical profile at just over 10 ft MLLW. This was a significant event for the site, yet overall damage was minimized by the heavily vegetated backshore/base of bank (Figure 21). Post-Isabel recovery is shown in Figure 19; the beach planforms have returned to approximately their pre-storm positions.

Figure 19. Kingsmill low-level pre- and post-Hurricane Isabel and recovery ortho-rectified aerial photos.

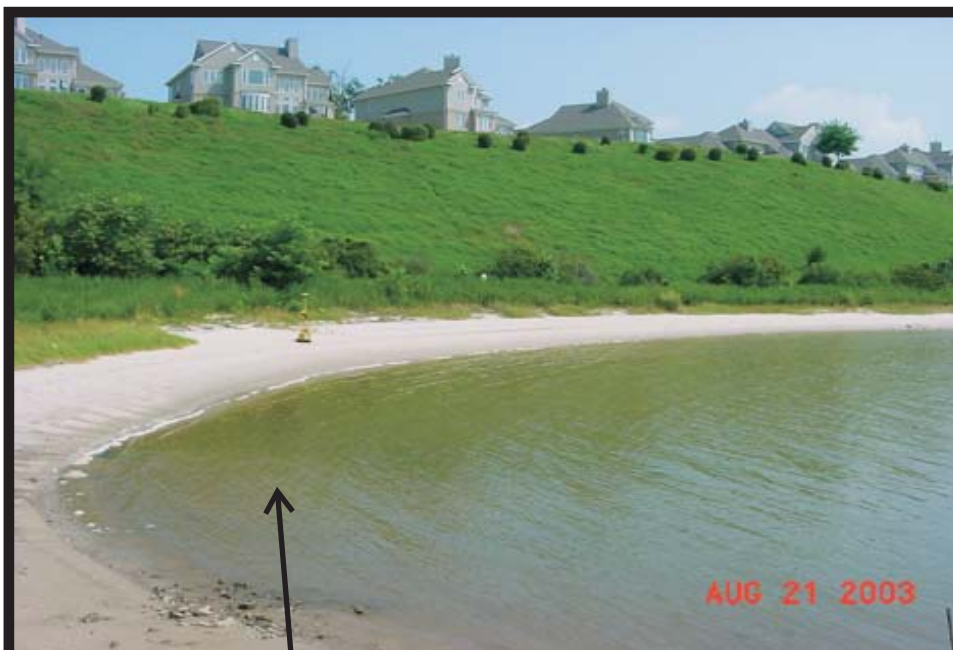
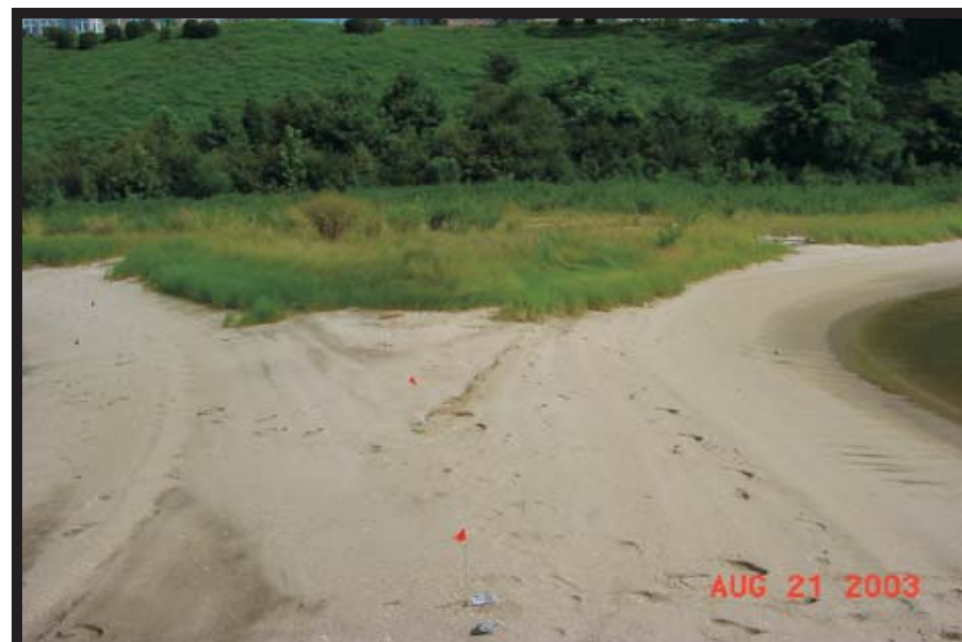
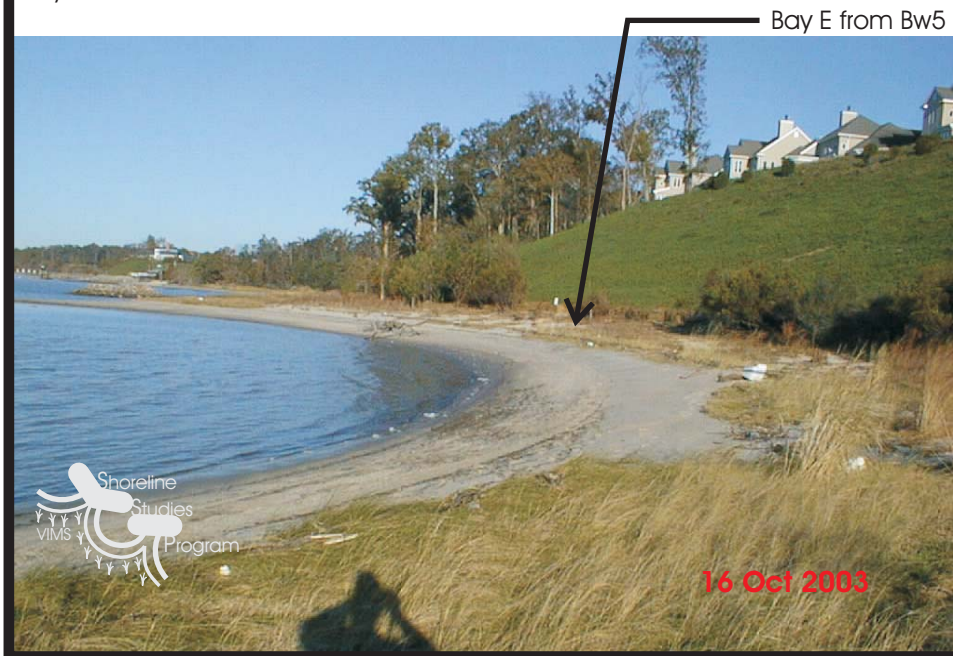
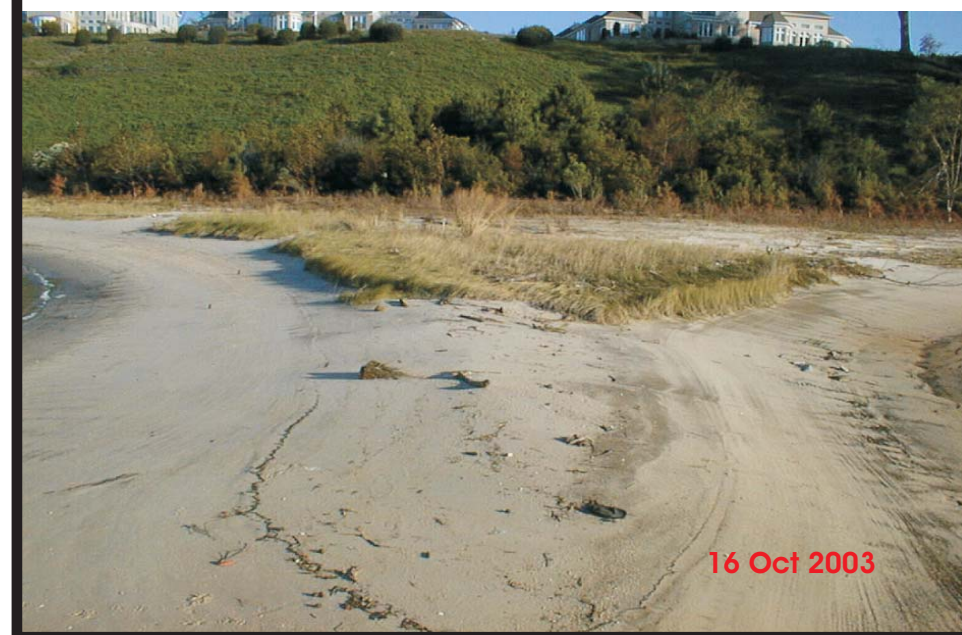
Figure 21. Kingsmill ground photos before and after Hurricane Isabel.

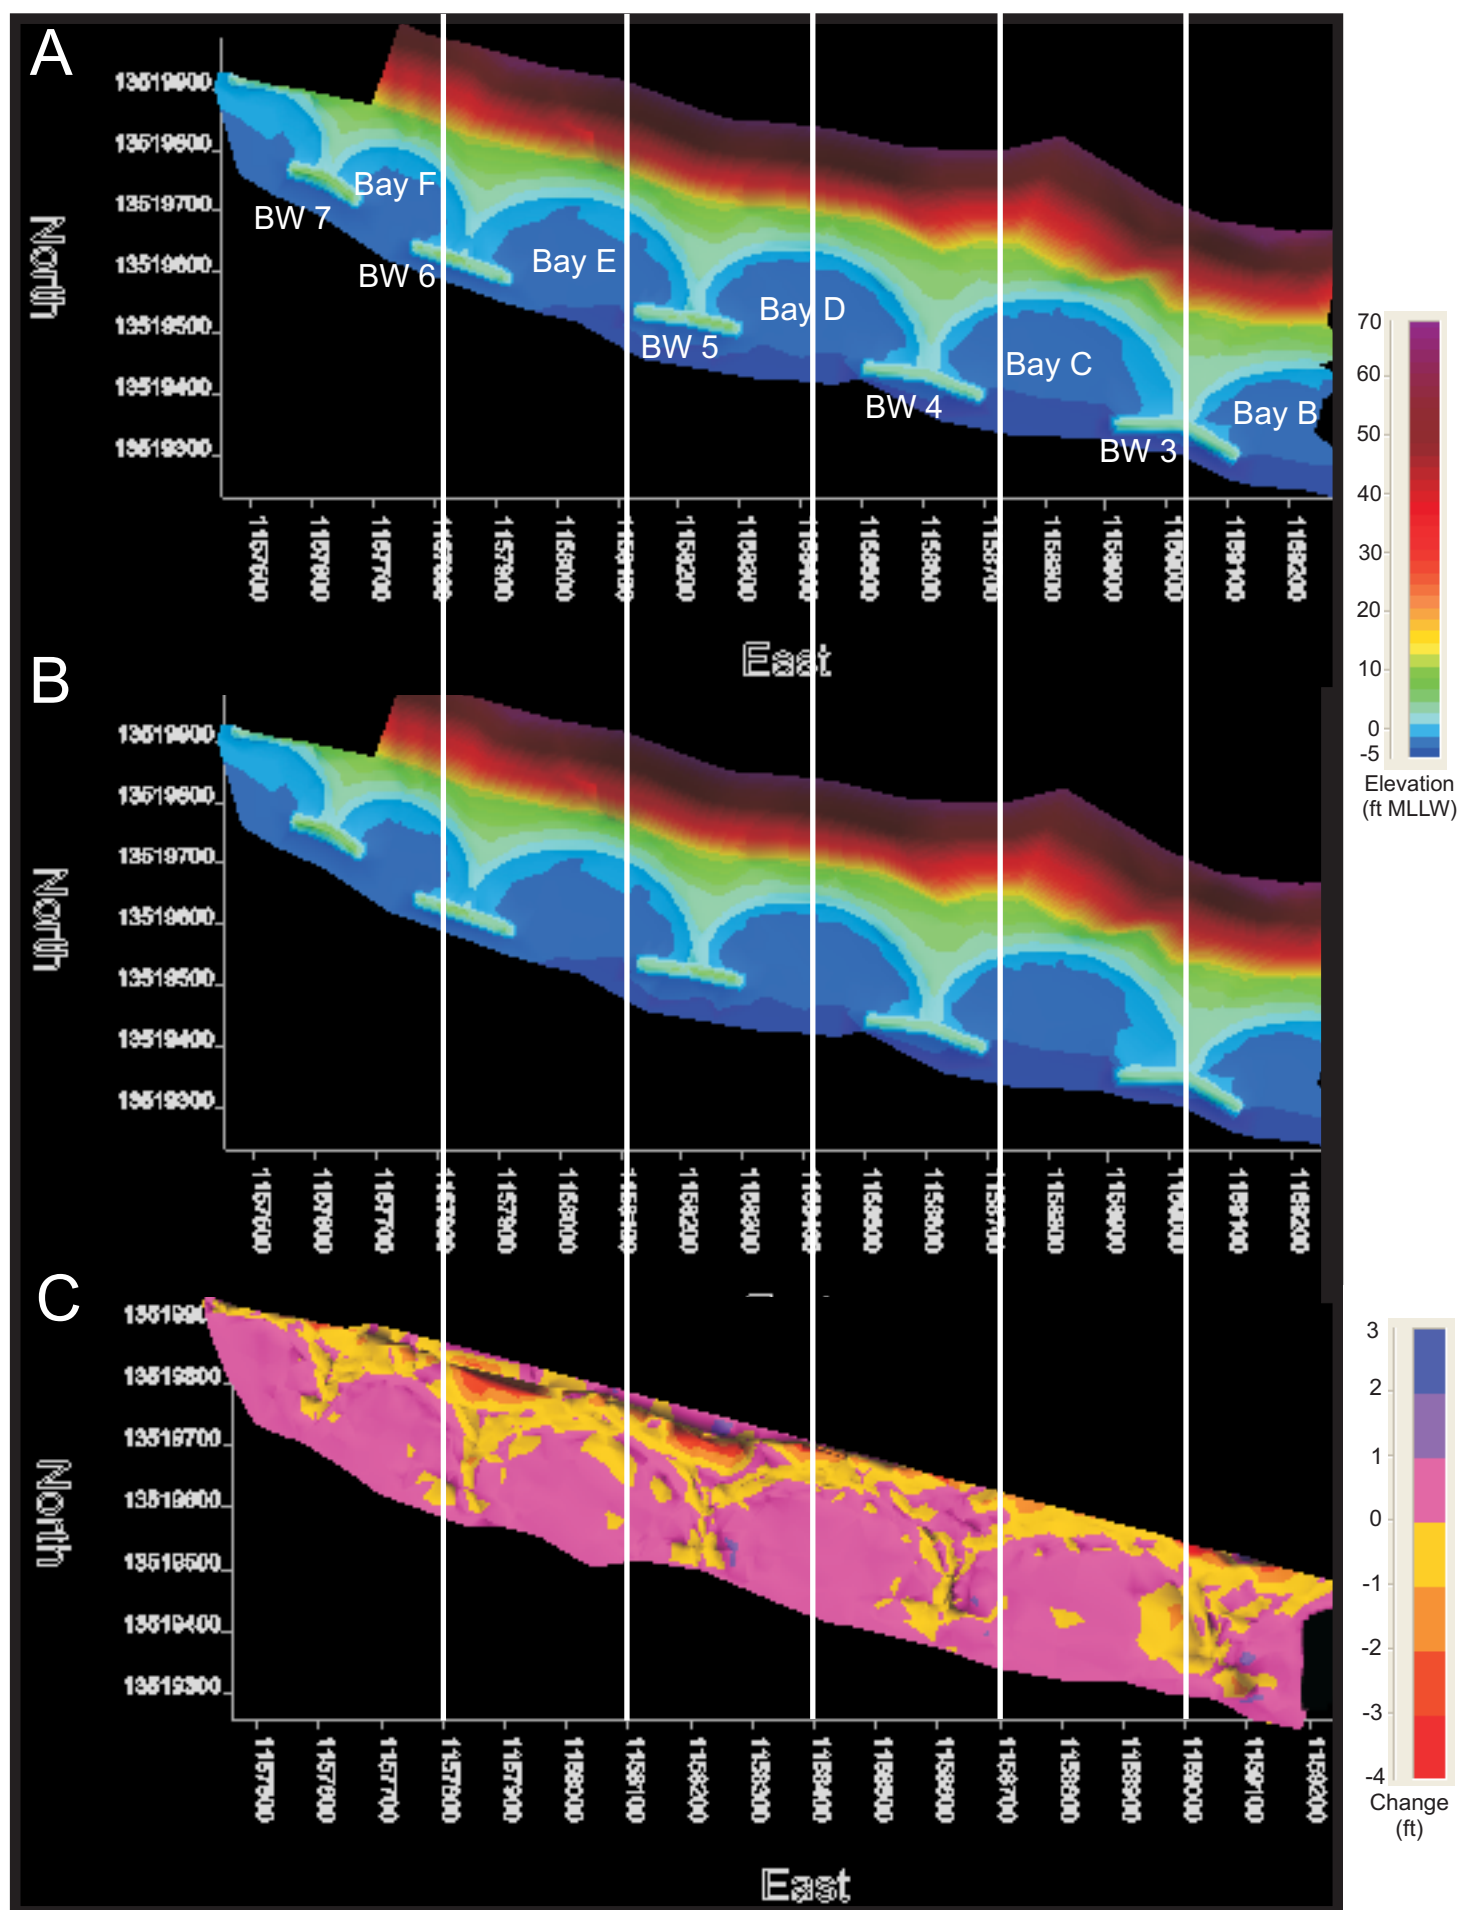
Topographic changes along the site between BW3 and BW7 are shown in Figure 22. The isopach map that indicates a general pattern of reduction in elevation occurred along the beach, backshore, base of bank and around each breakwater unit. Most increases in elevation were in the nearshore and in small pockets in the lee of each breakwater unit. The most severe scour occurred along the base of the bank (BOB) between BW5 and BW6. However, the damage did not endanger the integrity of the bank face. No slumping or failure was noted or has occurred since. Just upriver, extensive damage (more than \$3 million) occurred at the adjacent marina which only had a timber pile breakwater for protection.

Figure 22. Kingsmill color contour maps for the A) pre- and B) post-storm conditions and C) isopach map showing elevation changes between surveys.

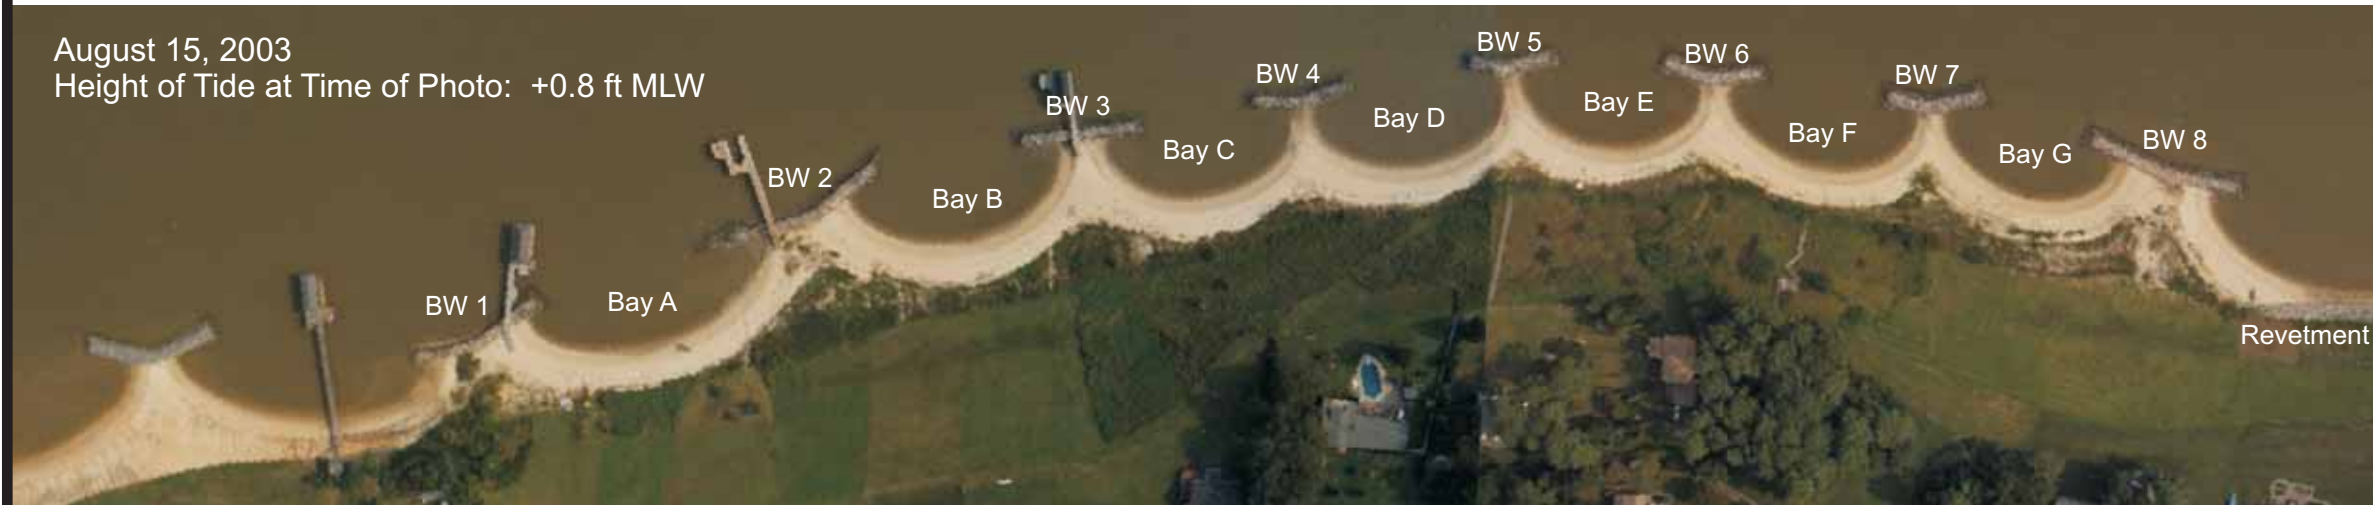
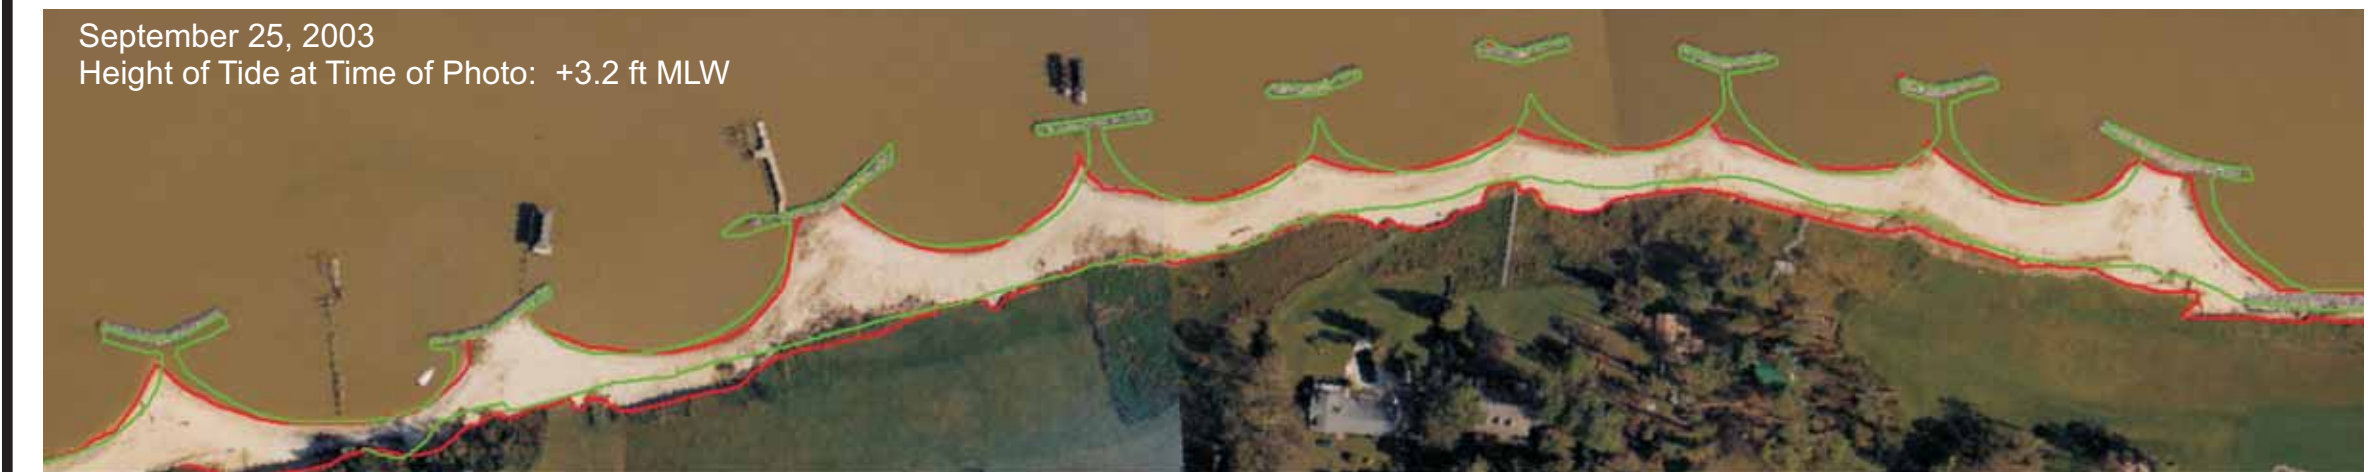
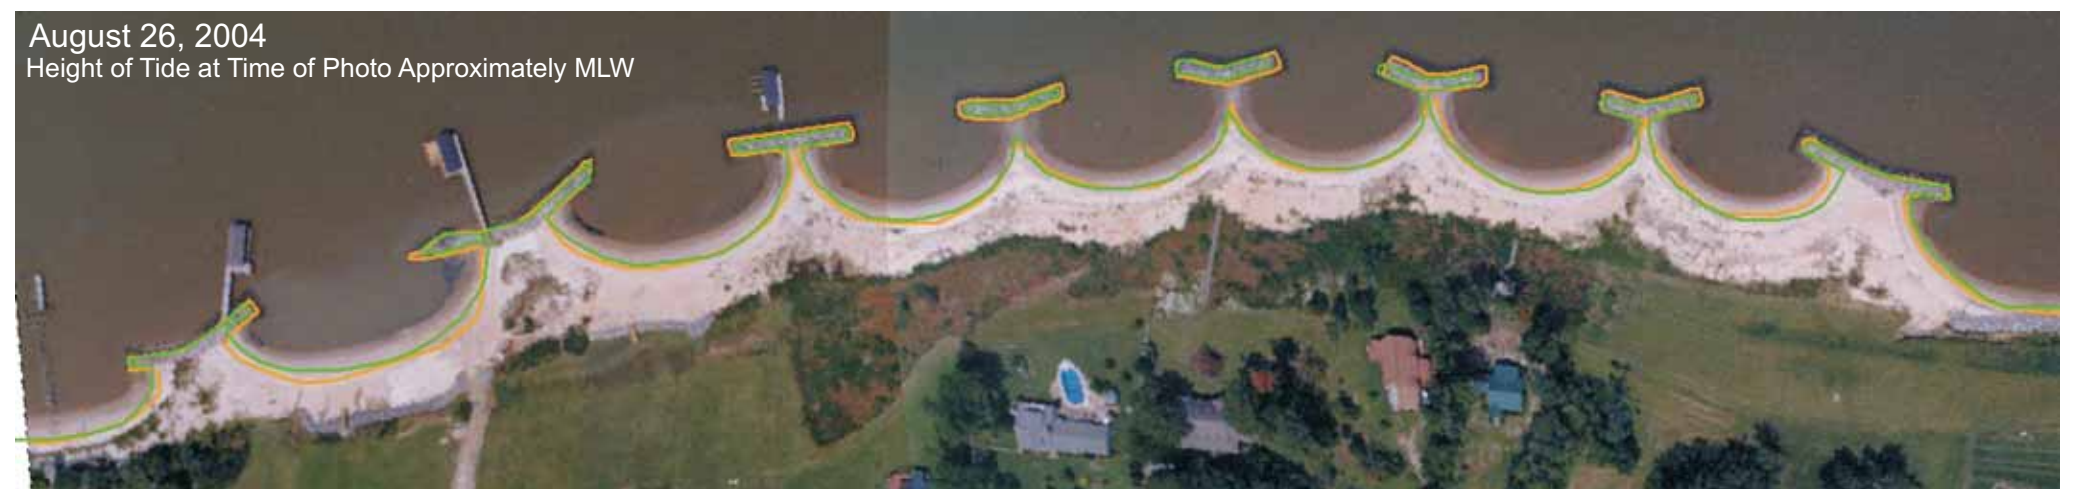
Figure 23. Van Dyke low-level pre- and post-Hurricane Isabel and recovery ortho-rectified aerial photos.
